**Eagle Picher
Ohio, Michigan, and Illinois Properties
TDD: S05-0603-003**

Site Inspection Reports

**Subject: Site Inspection Reports
Eagle Picher Ohio/Michigan/Illinois Properties
Technical Direction Document No. S05-0603-003
Tetra Tech Contract No. 68-W-00-129**

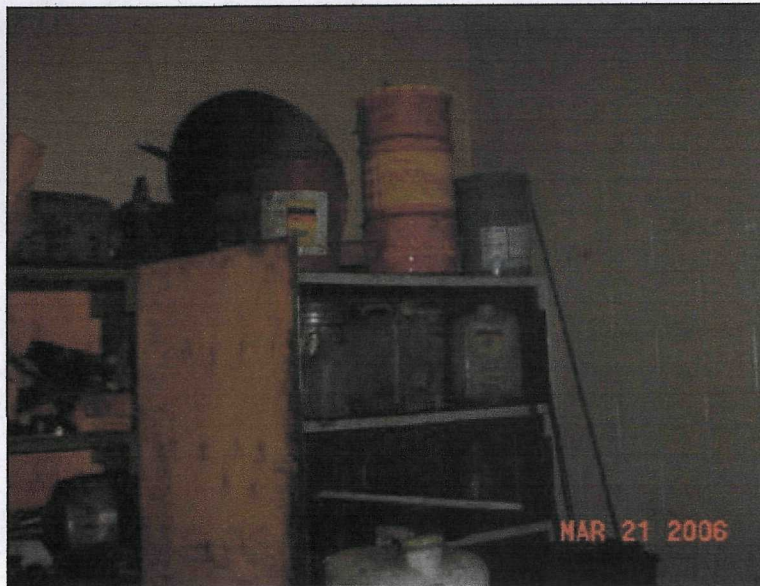
Photograph No. 5 **Date:** March 21, 2006
TDD No.: S05-0603-003 **Orientation:** Inside Building
Location: 135 East South Street, Hillsdale Michigan
Subject: Miscellaneous containers of petroleum product

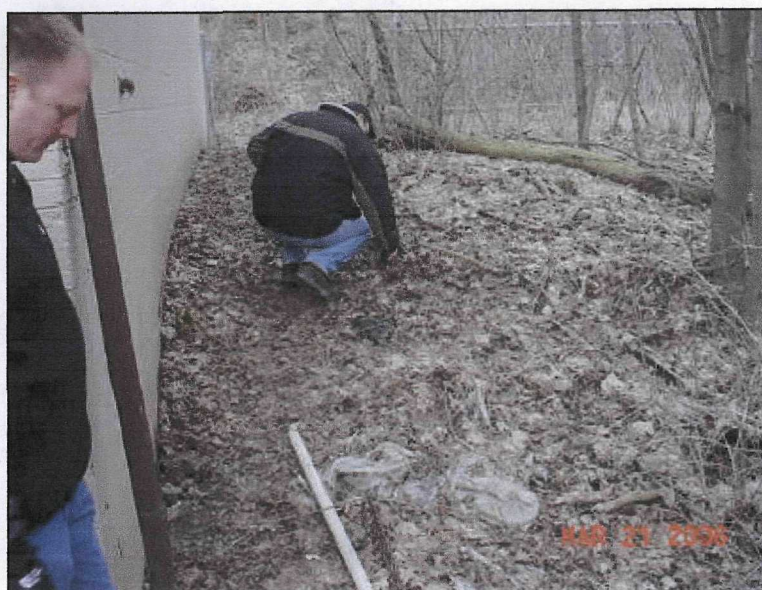
Photograph No. 7 **Date:** March 21, 2006
TDD No.: S05-0603-003 **Orientation:** West
Location: 135 East South Street, Hillsdale Michigan
Subject: OSC Gulch testing the soil with an XRF

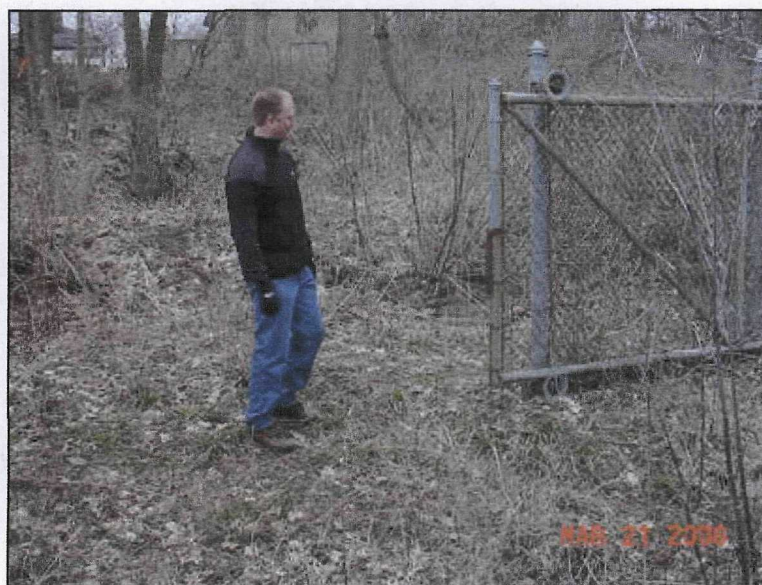
Photograph No. 8 **Date:** March 21, 2006
TDD No.: S05-0603-003 **Orientation:** West
Location: 135 East South Street, Hillsdale Michigan
Subject: Gate that was opened in the rear of the property. The gate could not be closed.

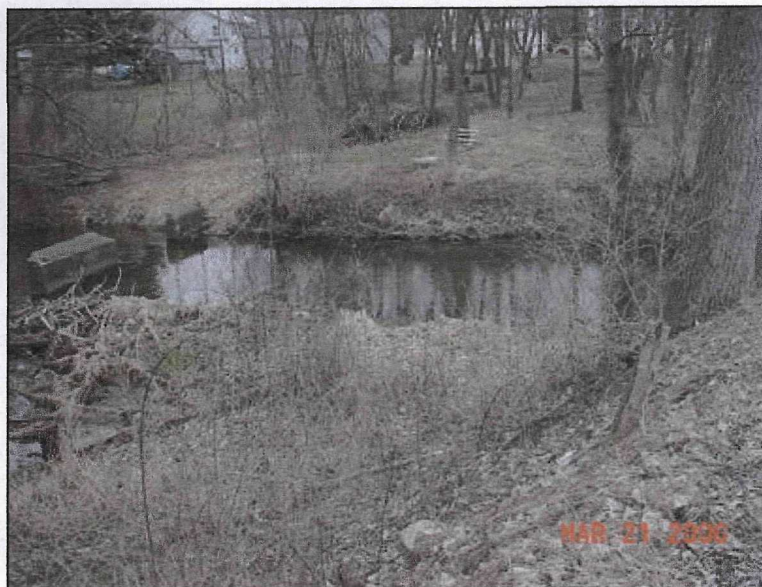
Photograph No. 9 **Date:** March 21, 2006
TDD No.: S05-0603-003 **Orientation:**
Location: 135 East South Street, Hillsdale Michigan
Subject: Branch of the St. Joseph River which borders the property to the east.

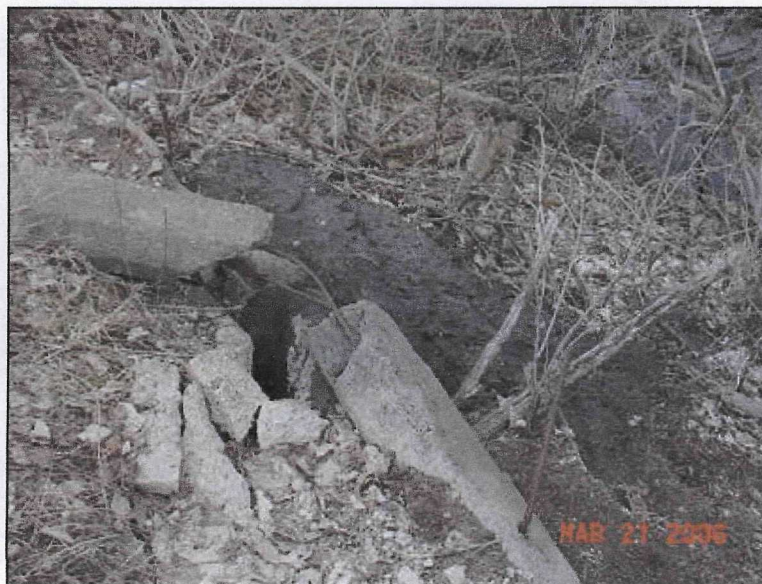
Photograph No. 10 **Date:** March 21, 2006
TDD No.: S05-0603-003 **Orientation:** Down
Location: 135 East South Street, Hillsdale Michigan
Subject: Pile of black sand at the northern edge of the property.

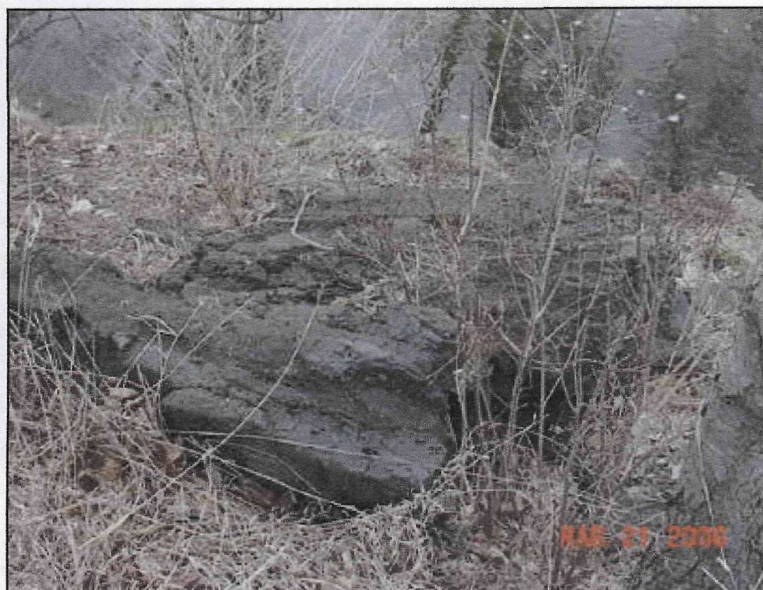
Photograph No.	11	Date:	March 21, 2006
TDD No.:	S05-0603-003	Orientation:	East
Location:	135 East South Street, Hillsdale Michigan		
Subject:	Slag that was dumped on the riverbank

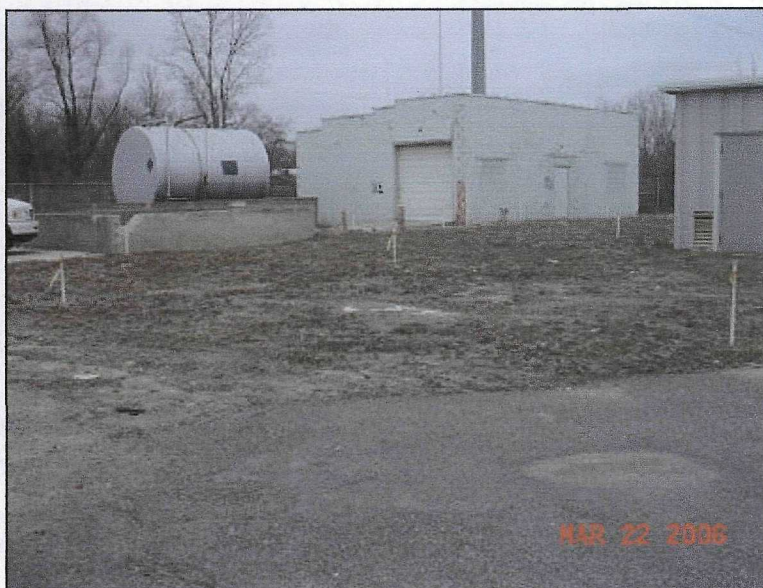
Photograph No. 3 **Date:** March 22, 2006
TDD No.: S05-0603-003 **Orientation:** Southwest
Location: 2638 Princess and 2424 John Daly, Inkster, Michigan
Subject: Hydrogen Peroxide injection field. Empty AST in background

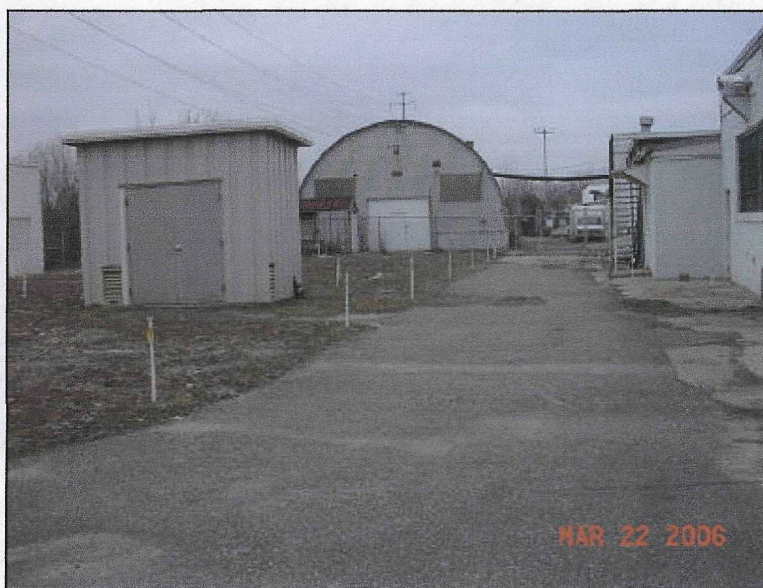
Photograph No. 4 **Date:** March 22, 2006
TDD No.: S05-0603-003 **Orientation:** West
Location: 2638 Princess and 2424 John Daly, Inkster, Michigan
Subject: Hydrogen Peroxide Injection field. Eagle Picher property ends at the
 fenceline, no monitoring wells have been installed on adjacent property.

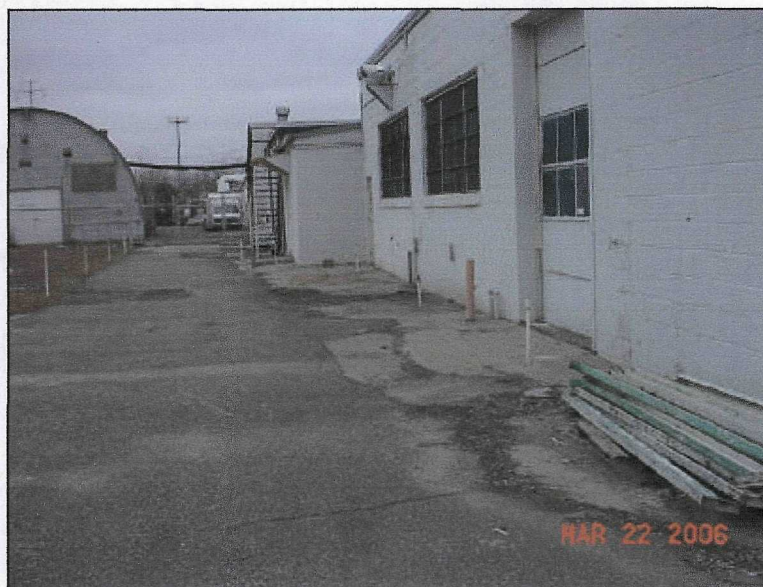
Photograph No. 5 **Date:** March 22, 2006
TDD No.: S05-0603-003 **Orientation:** West
Location: 2638 Princess and 2424 John Daly, Inkster, Michigan
Subject: Hydrogen Peroxide Injection field. Eagle Picher property ends at the
fenceline, no monitoring wells have been installed on adjacent property.

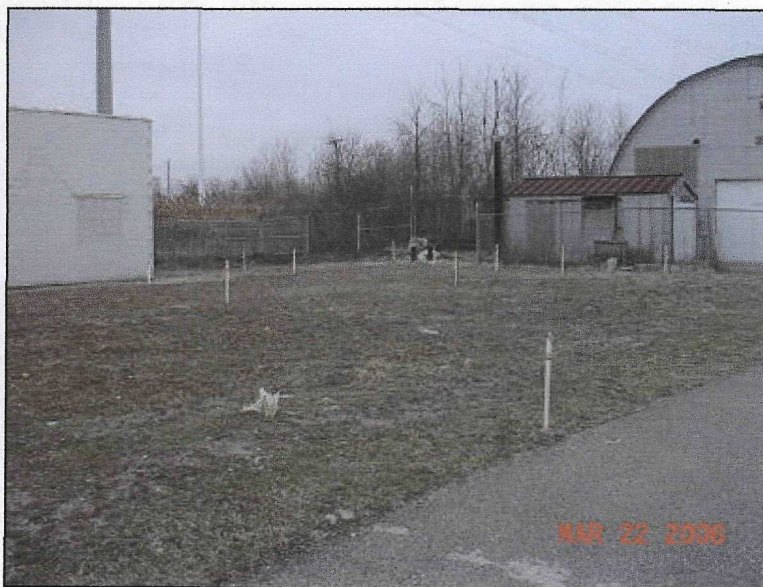
Photograph No. 6 **Date:** March 22, 2006
TDD No.: S05-0603-003 **Orientation:** Southwest
Location: 2638 Princess and 2424 John Daly, Inkster, Michigan
Subject: Hydrogen Peroxide injection field

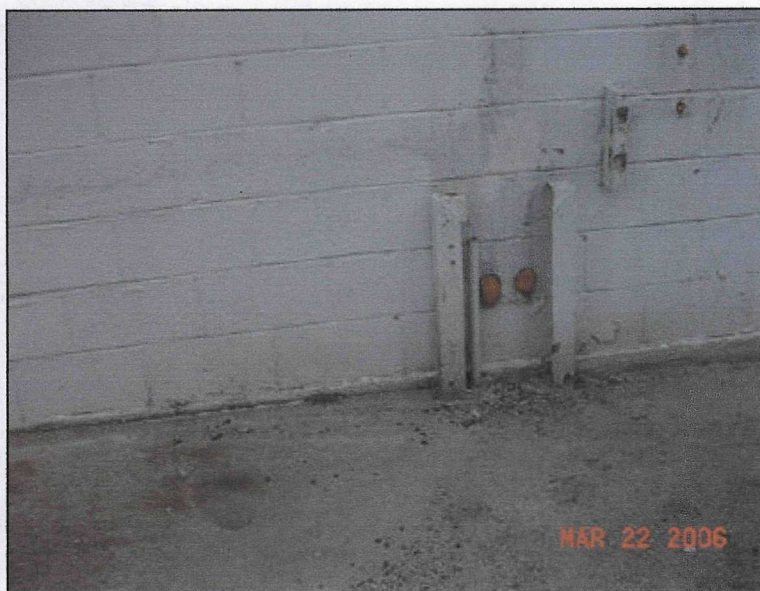
Photograph No. 7 **Date:** March 22, 2006
TDD No.: S05-0603-003 **Orientation:** North
Location: 2638 Princess and 2424 John Daly, Inkster, Michigan
Subject: Pipe leading from ground was once a solvent feed line

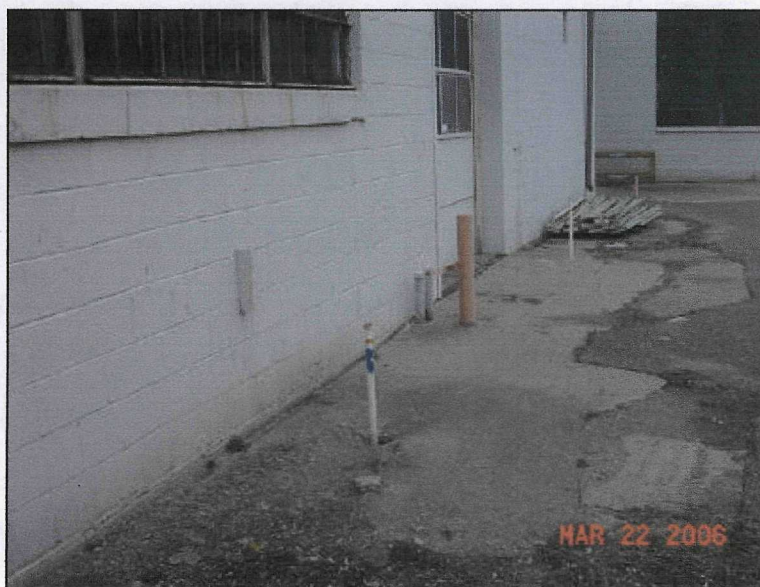
Photograph No. 8 **Date:** March 22, 2006
TDD No.: S05-0603-003 **Orientation:** East
Location: 2638 Princess and 2424 John Daly, Inkster, Michigan
Subject: Pipes leading from ground behind orange post were historically used as solvent feed lines

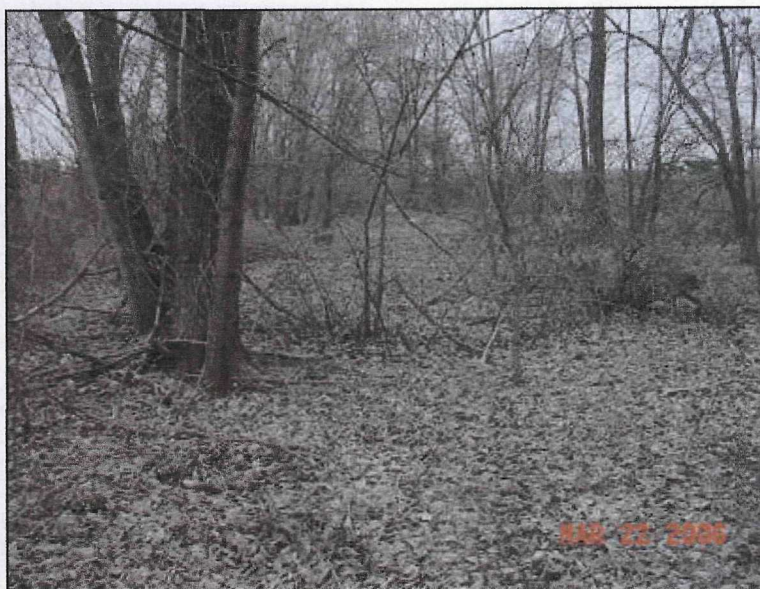
Photograph No. 1 **Date:** March 22, 2006
TDD No.: S05-0603-003 **Orientation:** Southwest
Location: River Rouge, Michigan
Subject: Typical property view

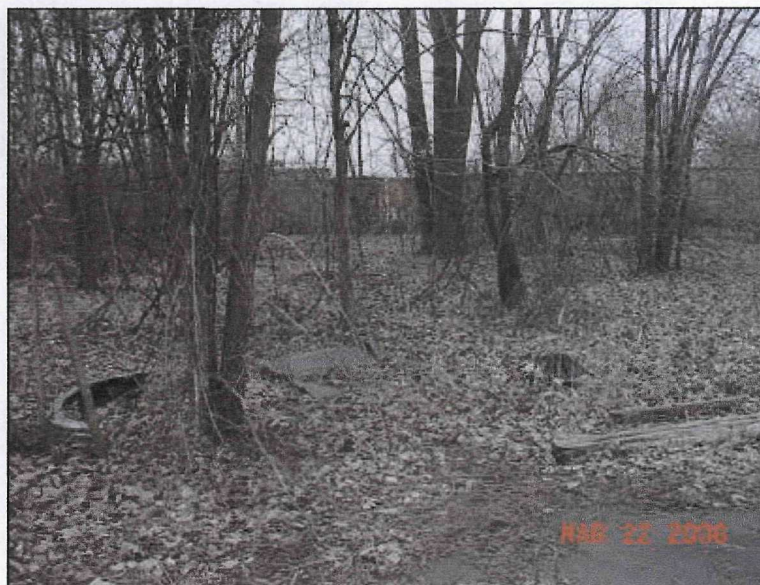
Photograph No. 2 **Date:** March 22, 2006
TDD No.: S05-0603-003 **Orientation:** West
Location: River Rouge, Michigan
Subject: Signs of dumping on the property (trash)

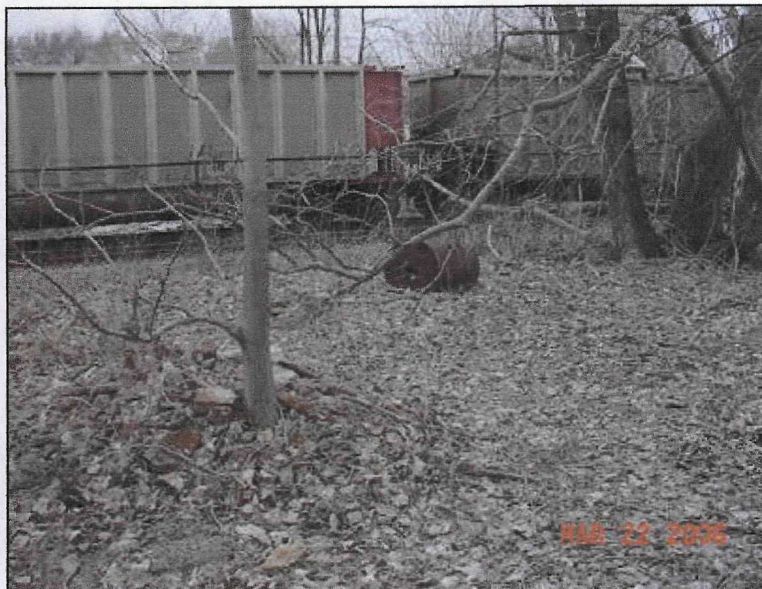
Photograph No. 3 **Date:** March 22, 2006
TDD No.: S05-0603-003 **Orientation:** West
Location: River Rouge, Michigan
Subject: Drum (empty) located on the property

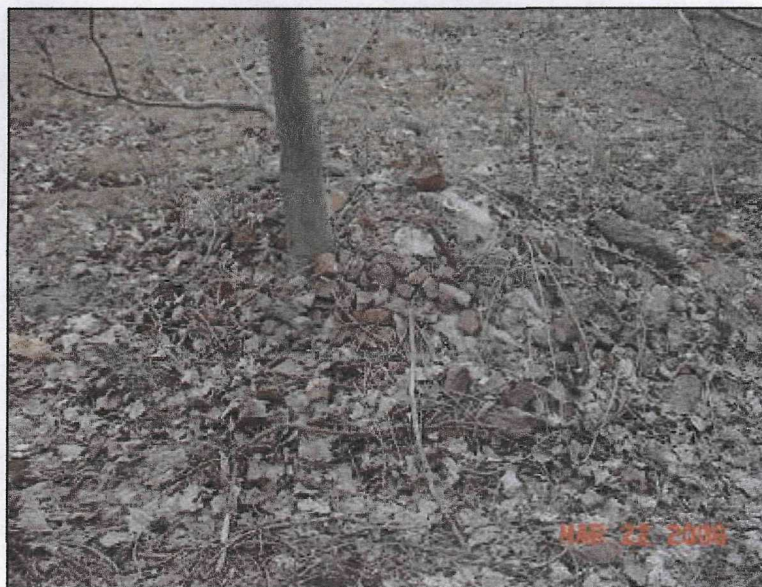
Photograph No. 4 **Date:** March 22, 2006
TDD No.: S05-0603-003 **Orientation:** Down
Location: River Rouge, Michigan
Subject: Signs of dumping
